Re: Exploration Project Permit E/023/033

**DETAILED CLOSURE AND RECLAMATION
PLANS FOR OPENINGS, PADS, ETC. IDENTIFIED
IN CONCERN #3, DOGM LETTER DATED
MARCH 5, 2001 BY WAYNE HEDBERG**

Detailed Closure and Reclamation Design Plans

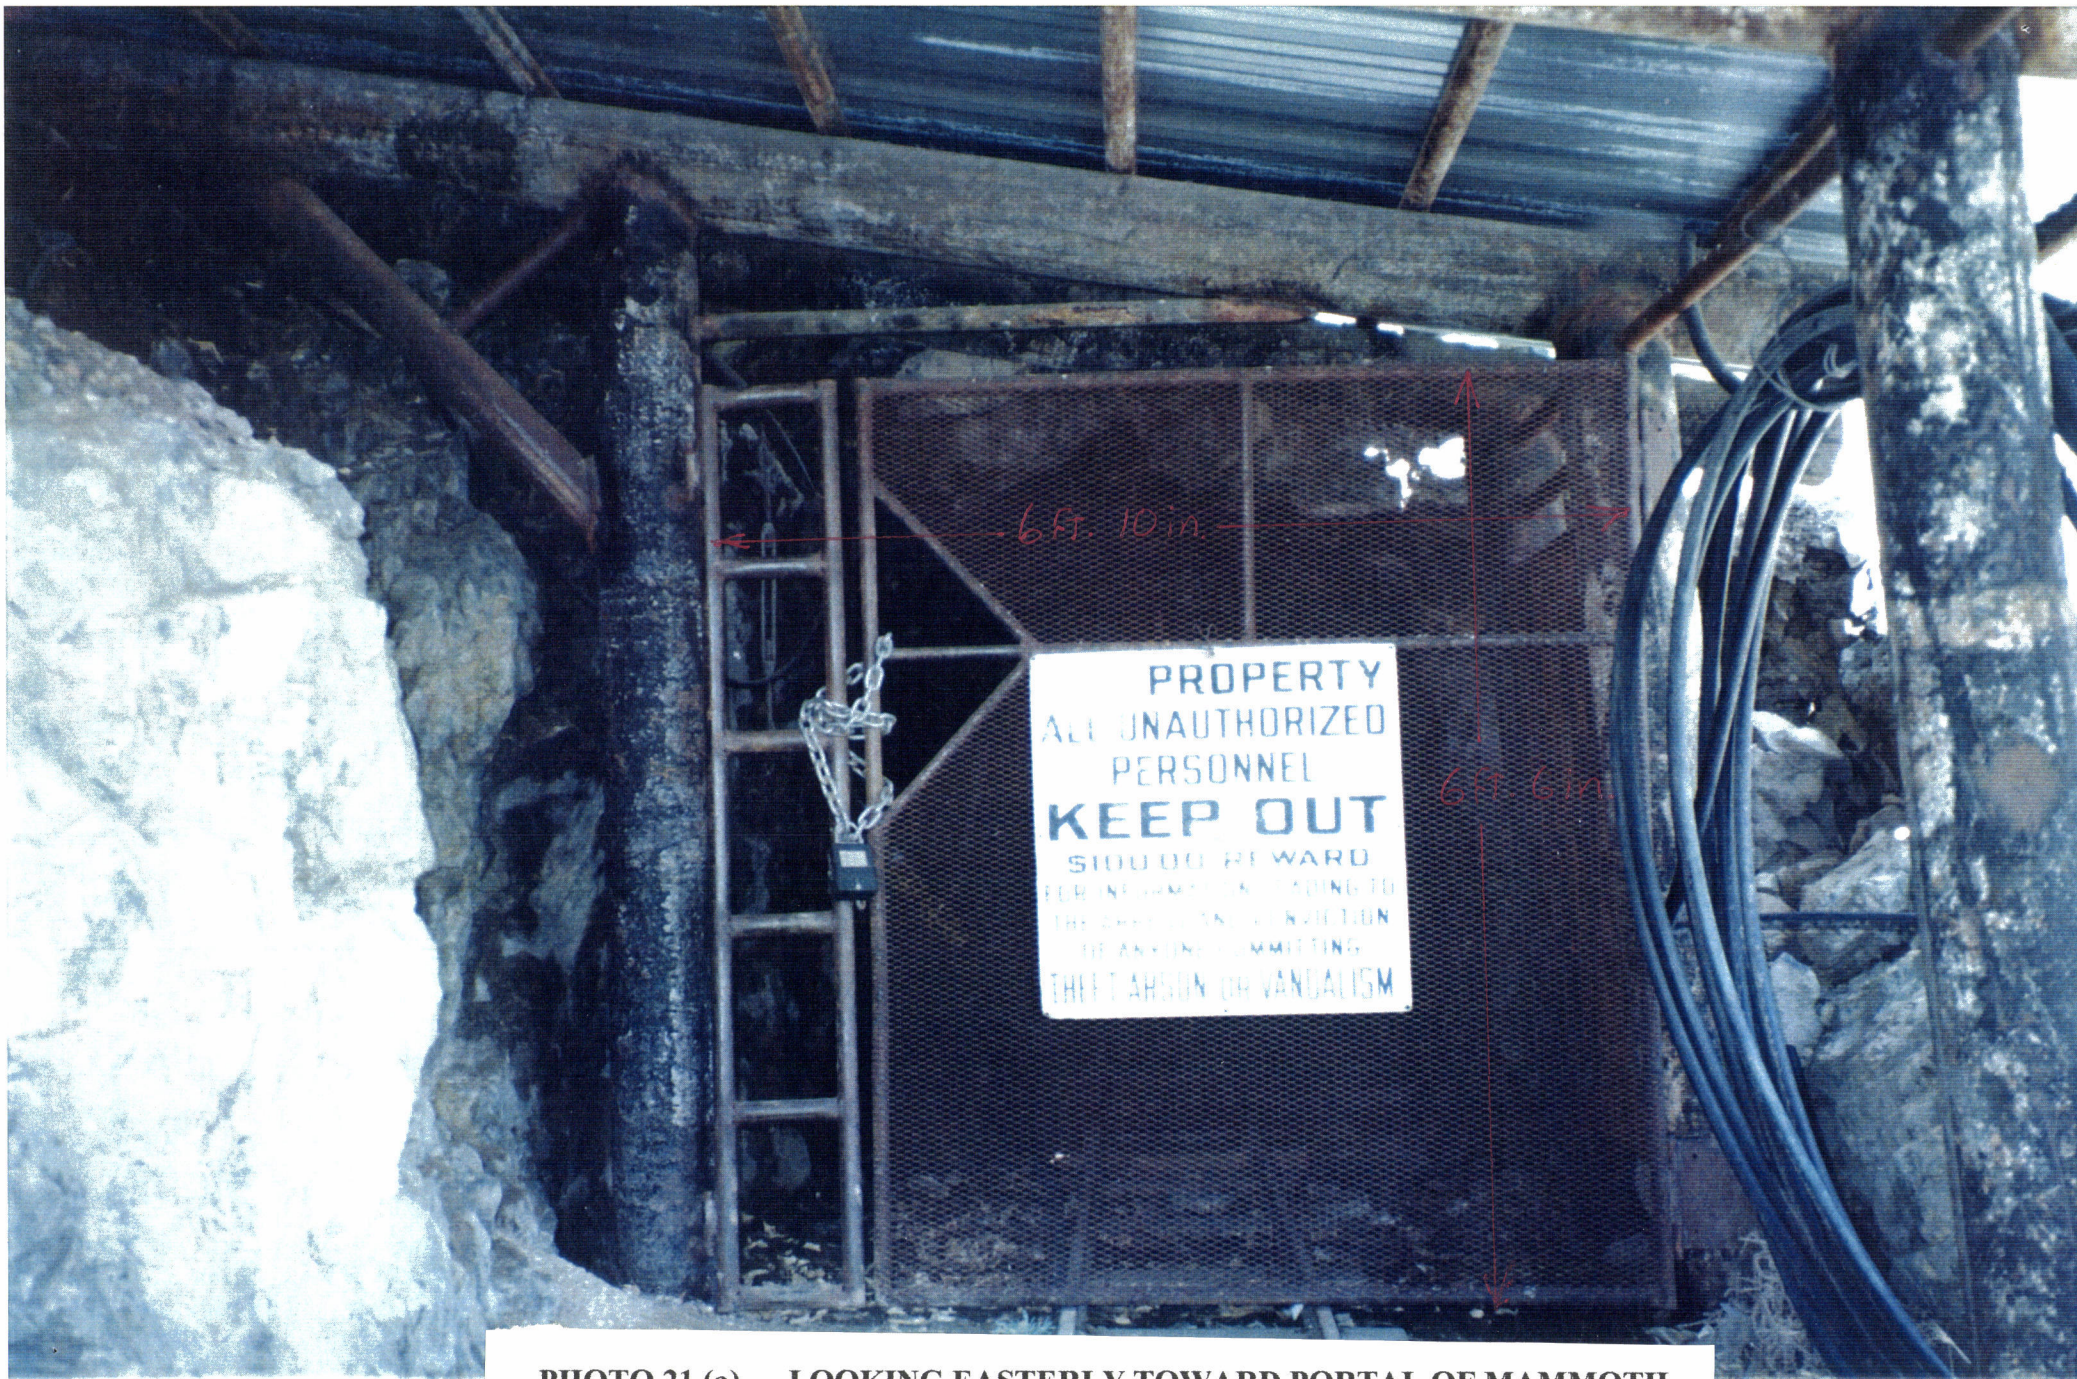
The entrance to the Mammoth 300 level tunnel is presently in very good condition, being constructed out of 8 in. diameter steel pipe and ¼ inch steel plate. The door is built in two sections with two hinges on each side with a chain and padlock holding them together. The south door is 5 ft. 10 in. wide, 6 ft. 6 in high, and is constructed of welded steel pipe and 1/8 inch thick steel diamond plate welded to the pipe. The maximum opening size on the south door is less than 1 inch. The north door is 1 ft. wide, and is constructed of welded steel pipe, with maximum opening size about 10 in. x 8 in. There is a gap of up to 1 ft. on both the top of the steel door and on the north side.

PHOTO 21 (a) --- LOOKING EASTERLY TOWARD PORTAL OF MAMMOTH 300 LEVEL TUNNEL. NOTE WELDED STEEL CONSTRUCTION FROM 8 INCH PIPE AND STEEL PLATE OUTSIDE PORTAL. NOTE ALSO WELL CONSTRUCTED HEAVY STEEL GATE WITH DIAMOND STEEL COVER.

We plan to weld 1 inch diameter steel pipe vertically on the north door to reduce the minimum dimension of openings to 4 inches. Also, we plan to weld additional sections of 1 inch steel pipe above the door and on the north side to reduce the minimum opening dimension to 4 inches or less. The hinges on the north door also will be strengthened and a protective padlock cover installed that is resistant to sledge damage and to hack saw removal. These modifications to the existing steel gate will prevent unauthorized access.. See Appendix 21

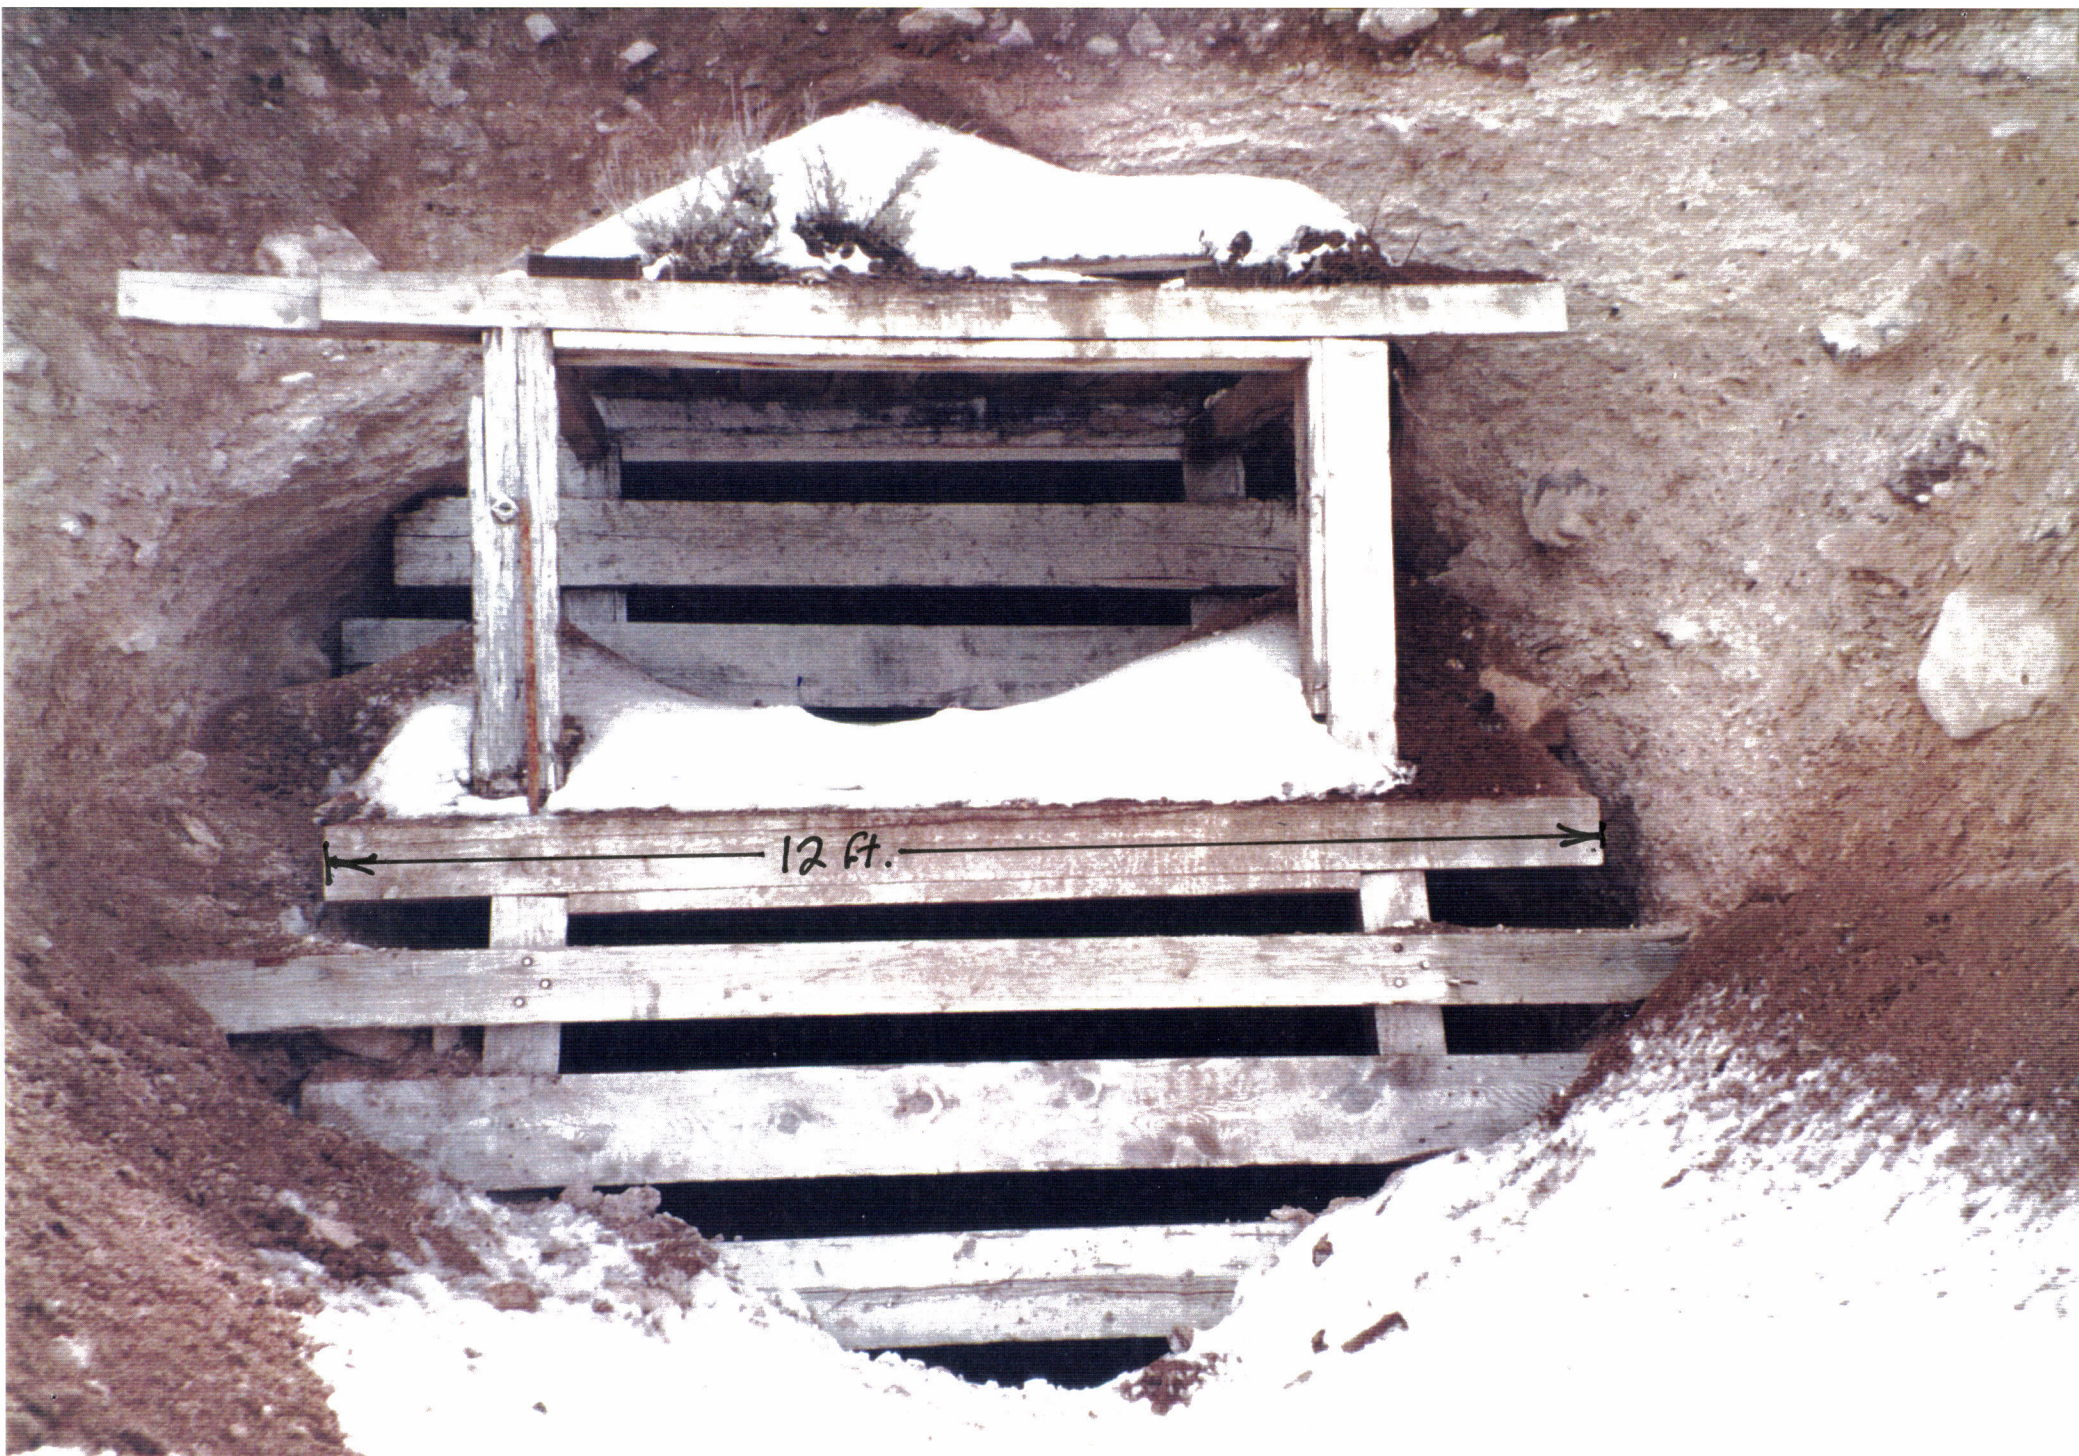
About 1989 Centurion Mines Corporation installed a locked steel gate to prevent unauthorized access to the Holden Tunnel. These barriers are situated 41 feet apart (see photos 1-a and 1-b attached herewith). The outer barrier is constructed of mine timbers (8 in. x 8 in. timbers and 12 in. x 2 in. lagging). 41 feet inside the outer barrier a locked steel gate is installed which is firmly attached to the rock sides and roof around the tunnel opening. In order to access and inspect the inner steel gate, it was necessary to partially disassemble the outer timber barrier. This was done on or about March 31, 2001 by an

**PHOTO 1 (a) --- LOOKING SOUTHEASTERLY TO OUTER TIMBER BARRIER
BLOCKING PORTAL OF THE HOLDEN TUNNEL.**

A. Outer Timber Barrier at Mouth of the Tunnel.

Remove the existing lagging and add additional pieces of lagging to make certain the spaces between lagging are 4 inches or less. The lagging will be reattached to the timbers using 3/8 inch lag screws 8 inches long instead of the present much smaller wood crews. This will render access through the outer barrier very difficult. The 4 inch space between the lagging will keep people out and still permit normal air flow to occur, and will provide access for small animals. See diagram in Appendix 1 at the end of this proposal.

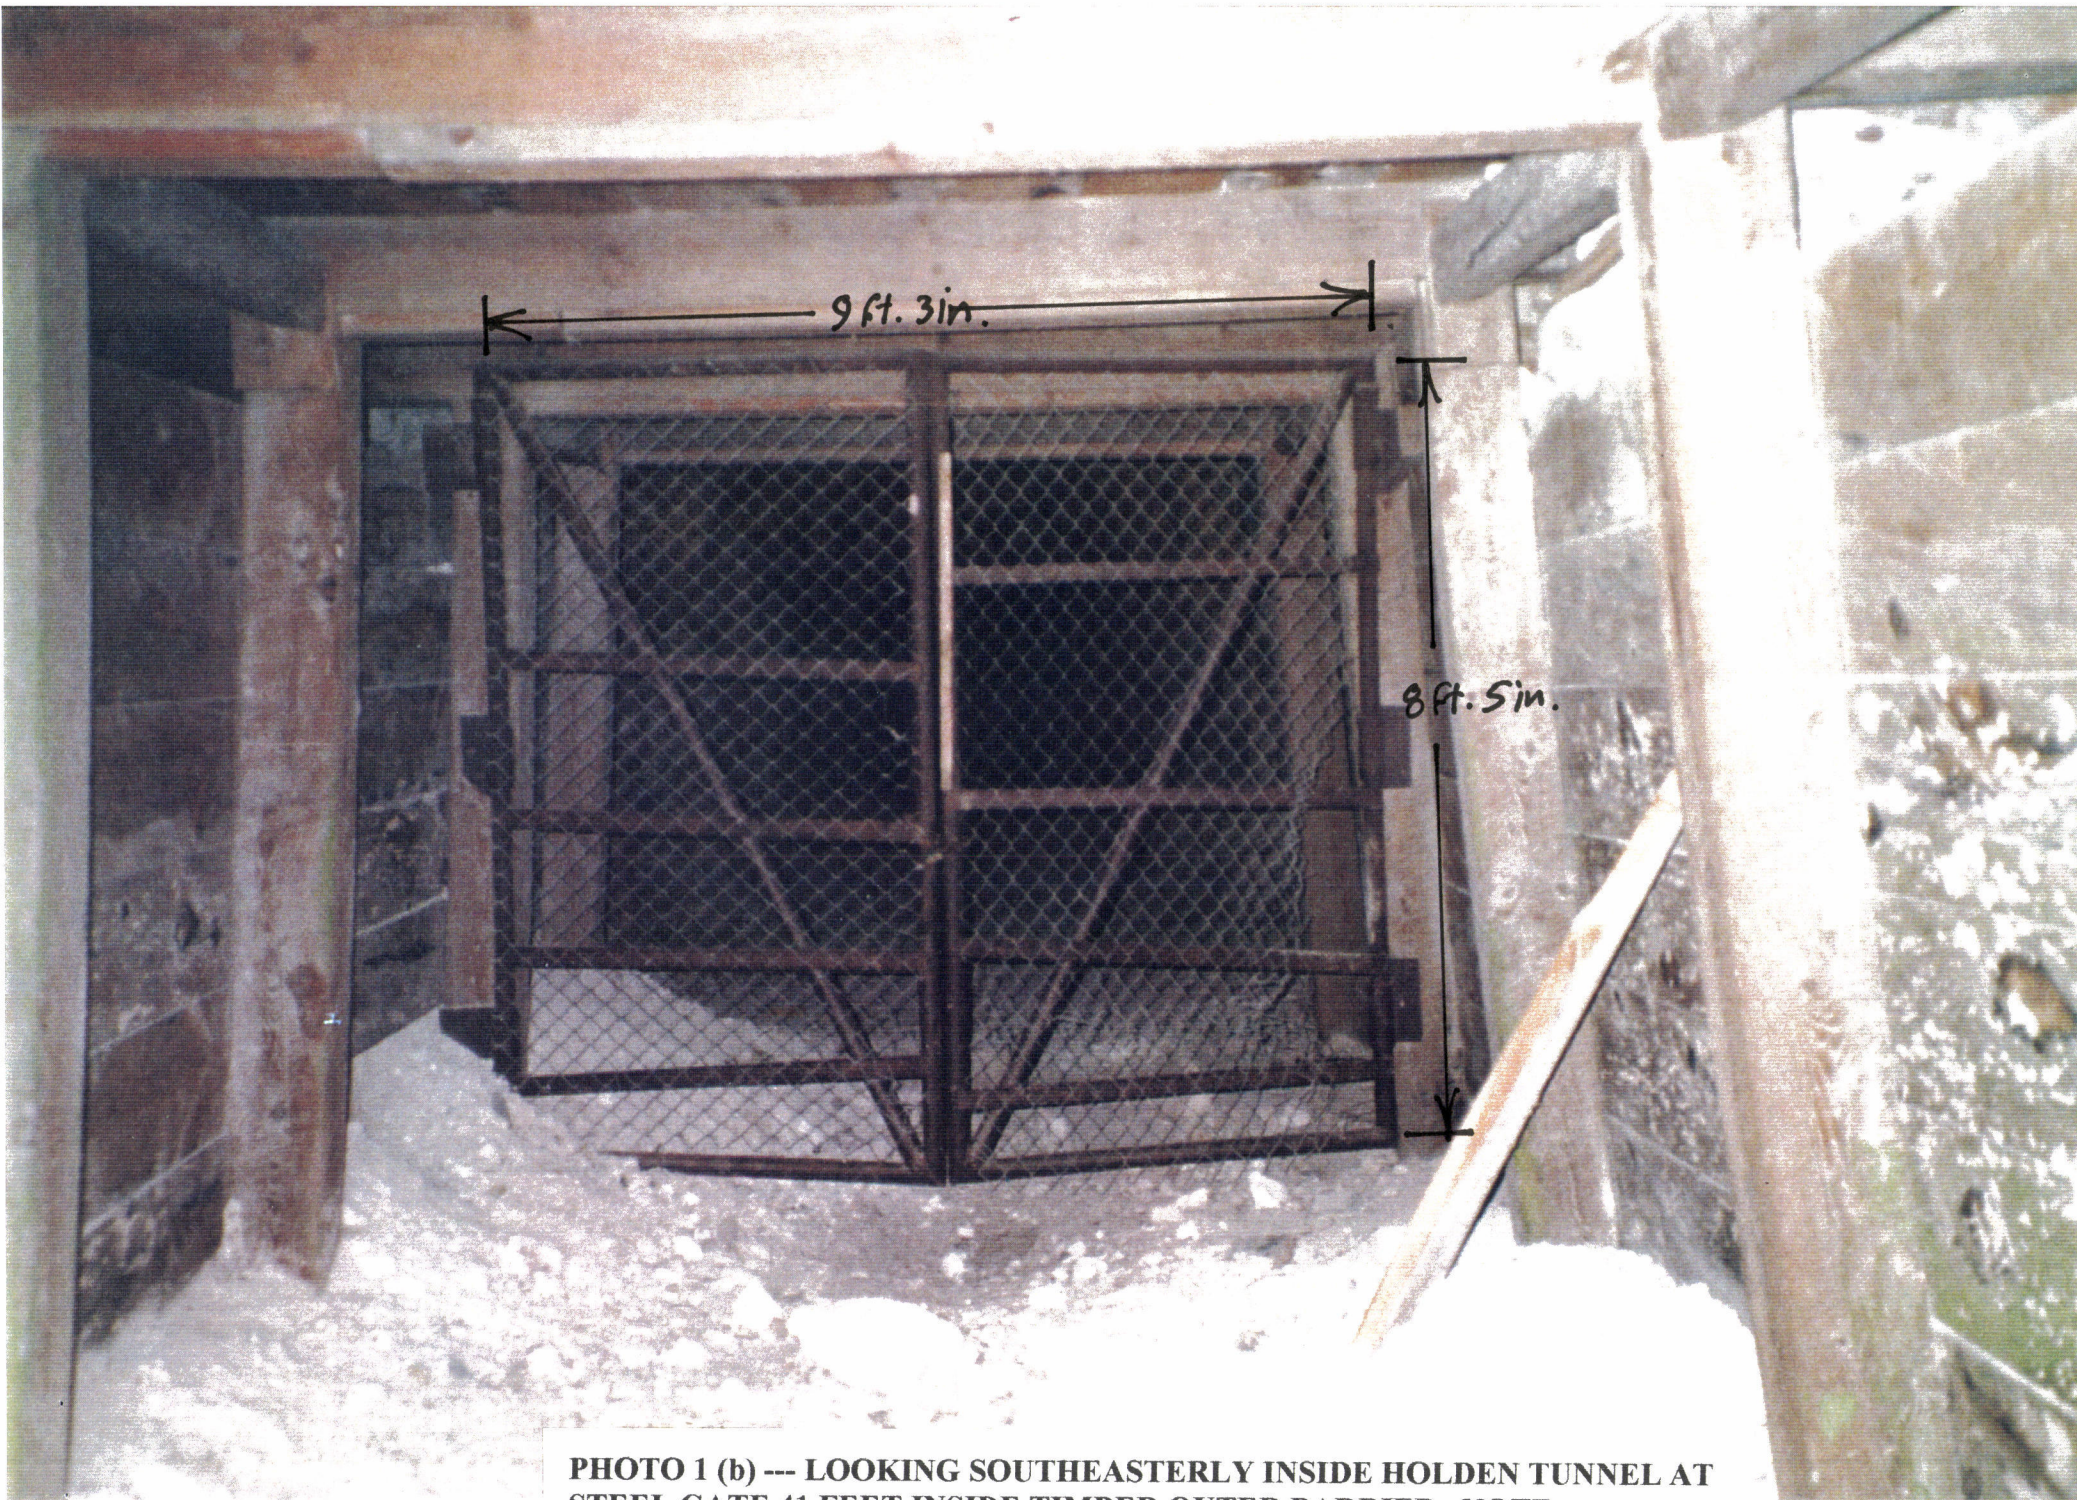
The existing steel gate is 8 ft. 5 in. in height and 9 ft. 3 in. wide, and is double swinging with a chain and lock in the center. Each of the two doors have 3 hinges that are welded to the steel gate and are attached by screws to the upright mine timbers firmly attached to the surrounding rock. The gate is constructed of 2 in. steel pipe welded together covered by chain link fencing wired in place. Our plan is to re-attach the hinges to the upright mine timbers using carriage bolts that cannot be removed from the front of the gate. We plan then to remove the chain link fencing and replace it with horizontal 1 in. steel pipe welded in place with not more than 4 inches of space between the pipe. The gate will be kept locked using a secure steel locking device so constructed that it is protected from destruction by sledge and hacksaw.

PHOTO 1 (b) --- LOOKING SOUTHEASTERLY INSIDE HOLDEN TUNNEL AT STEEL GATE 41 FEET INSIDE TIMBER OUTER BARRIER. NOTE YARDSTOCK FOR SCALE.

B. Inner Steel Gate.

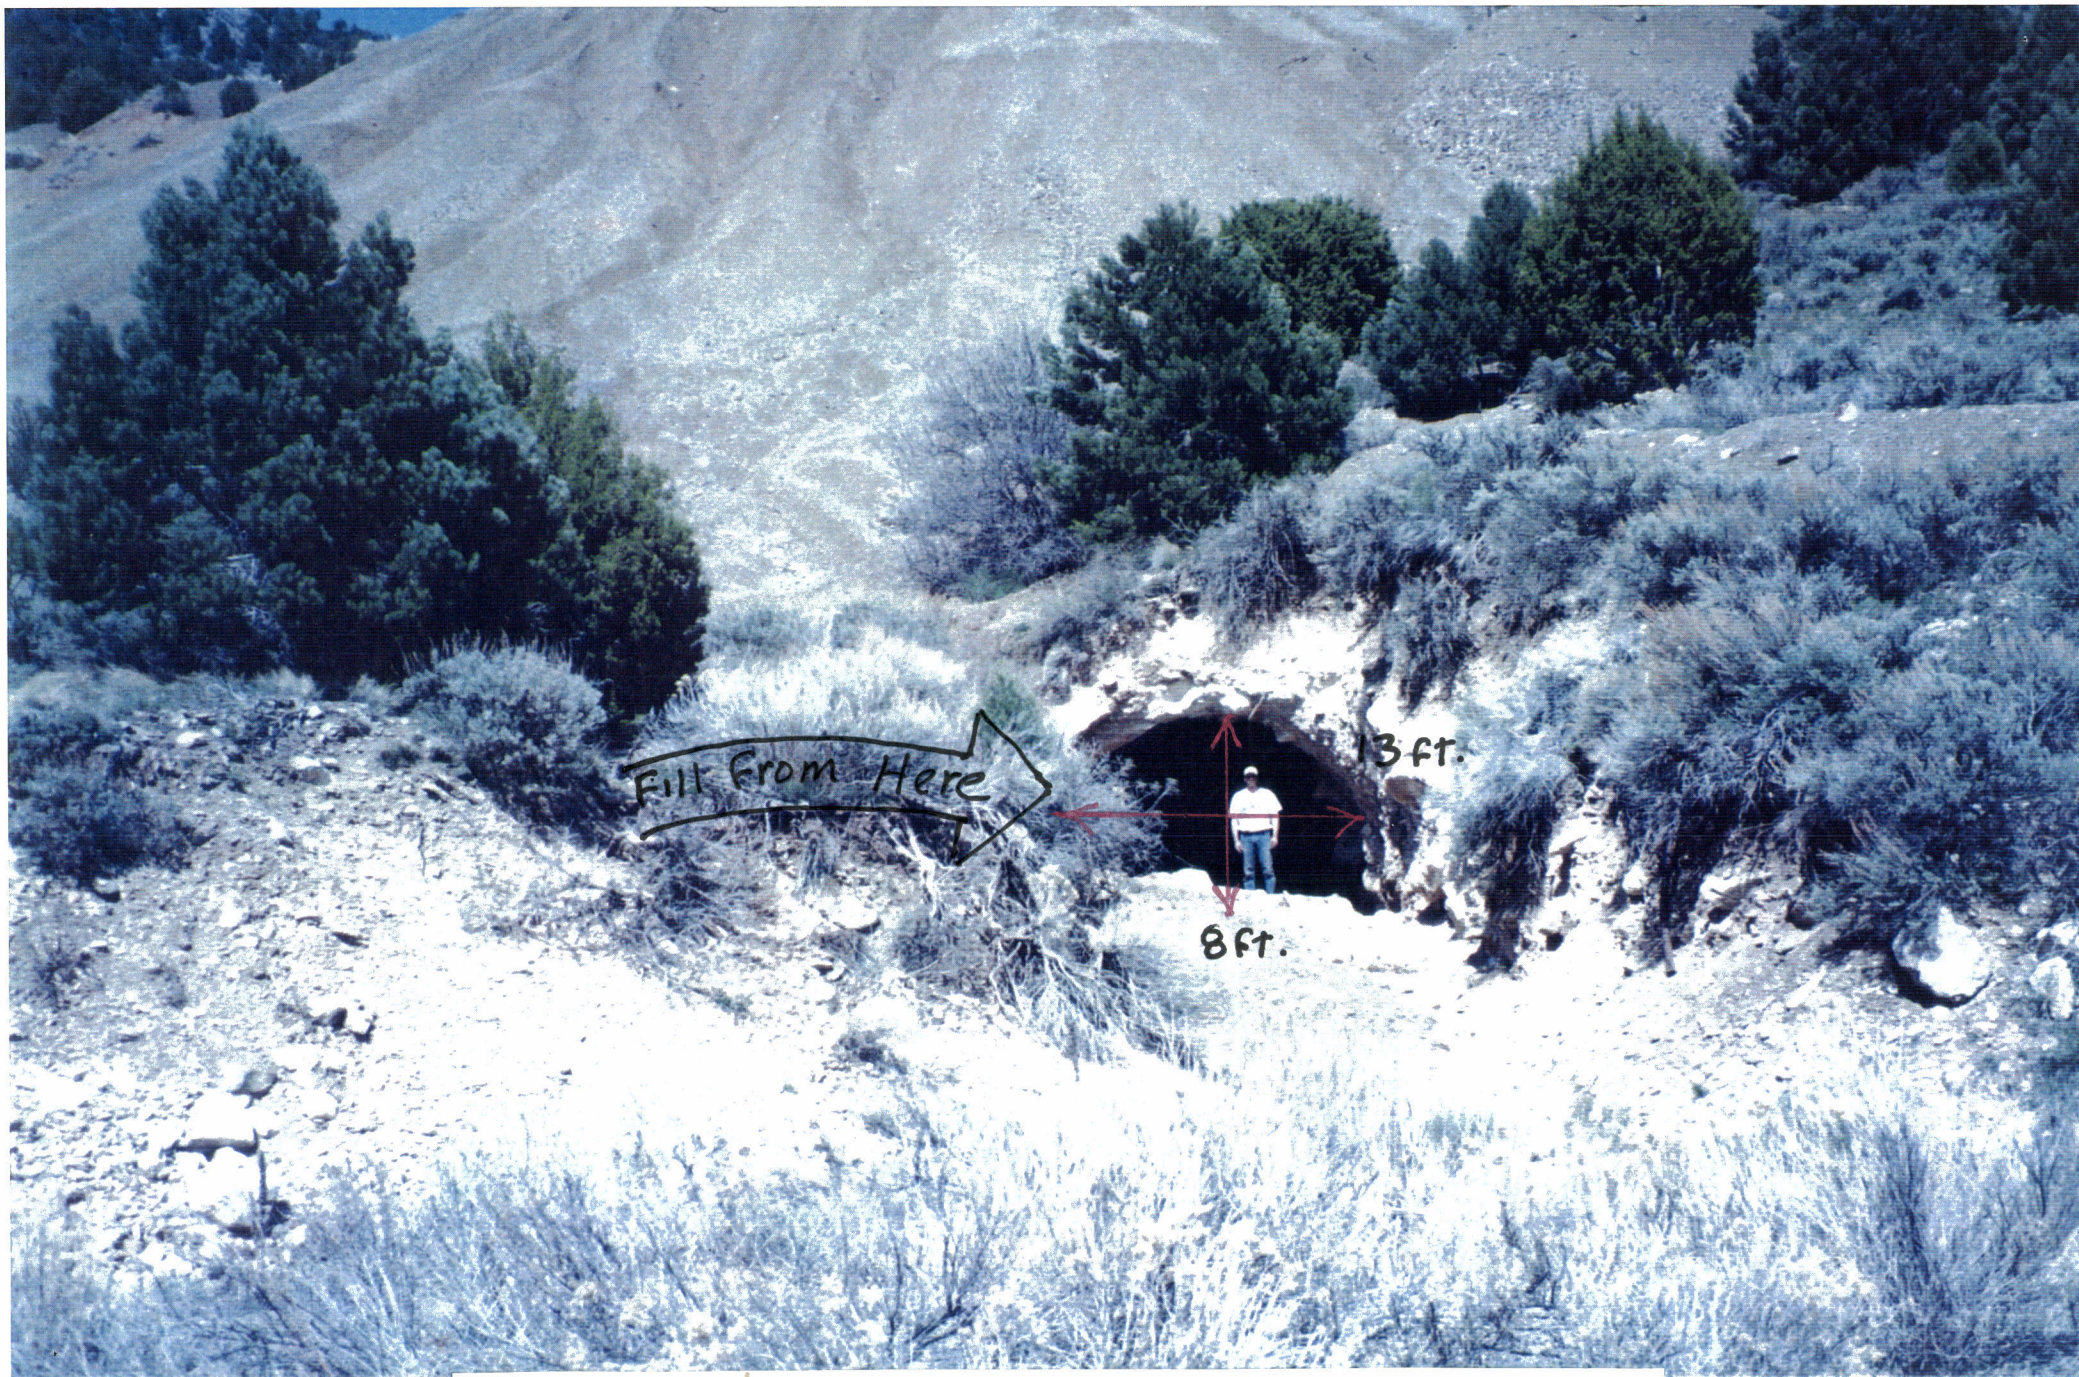
expensive than had been anticipated. At the present time the tunnel is believed to be dangerous because of weak and caving "ground" surrounding the present opening.

PHOTO 4 (a) --- LOOKING NORTHERLY TO PORTAL OF GRAND CENTAL TUNNEL. NOTE MINE DUMP AND ALLUVIAL FILL ON SOUTH (LEFT) SIDE. NOTE UNCONSOLIDATED "LIP" ABOVE TUNNEL PORTAL.

It is planned that a bulldozer be used to move soft mine dump material and unconsolidated alluvial material situated immediately to the west of the tunnel mouth to block the tunnel opening. It is further planned that at least 10 to 12 feet of material be placed in front of the tunnel opening, and pushed inside the tunnel in the amount reasonably possible. As soon as the fill material is in place, the upper lip of the tunnel will be caved down to make the sealing of the tunnel opening complete. Additional fill material will be pushed in front of and above the present tunnel opening to provide a further barrier. Rock outcrops to the east of the tunnel opening indicate that only limited quantities of fill material will be available from that side. Because of caving conditions, it is considered unwise for heavy mechanized equipment to attempt to operate on top of the tunnel until it has been filled from the front. Until the portal is filled, the tunnel top could cave in under the weight of a bulldozer or backhoe with possible injury to the operating personnel. A local earth-moving contractor will be used for this work.

Immediately after the tunnel has been filled, the surface will be smoothed with hand tools (rakes and shovels) and native seeds will be planted so that the surface will be re-vegetated with native species.

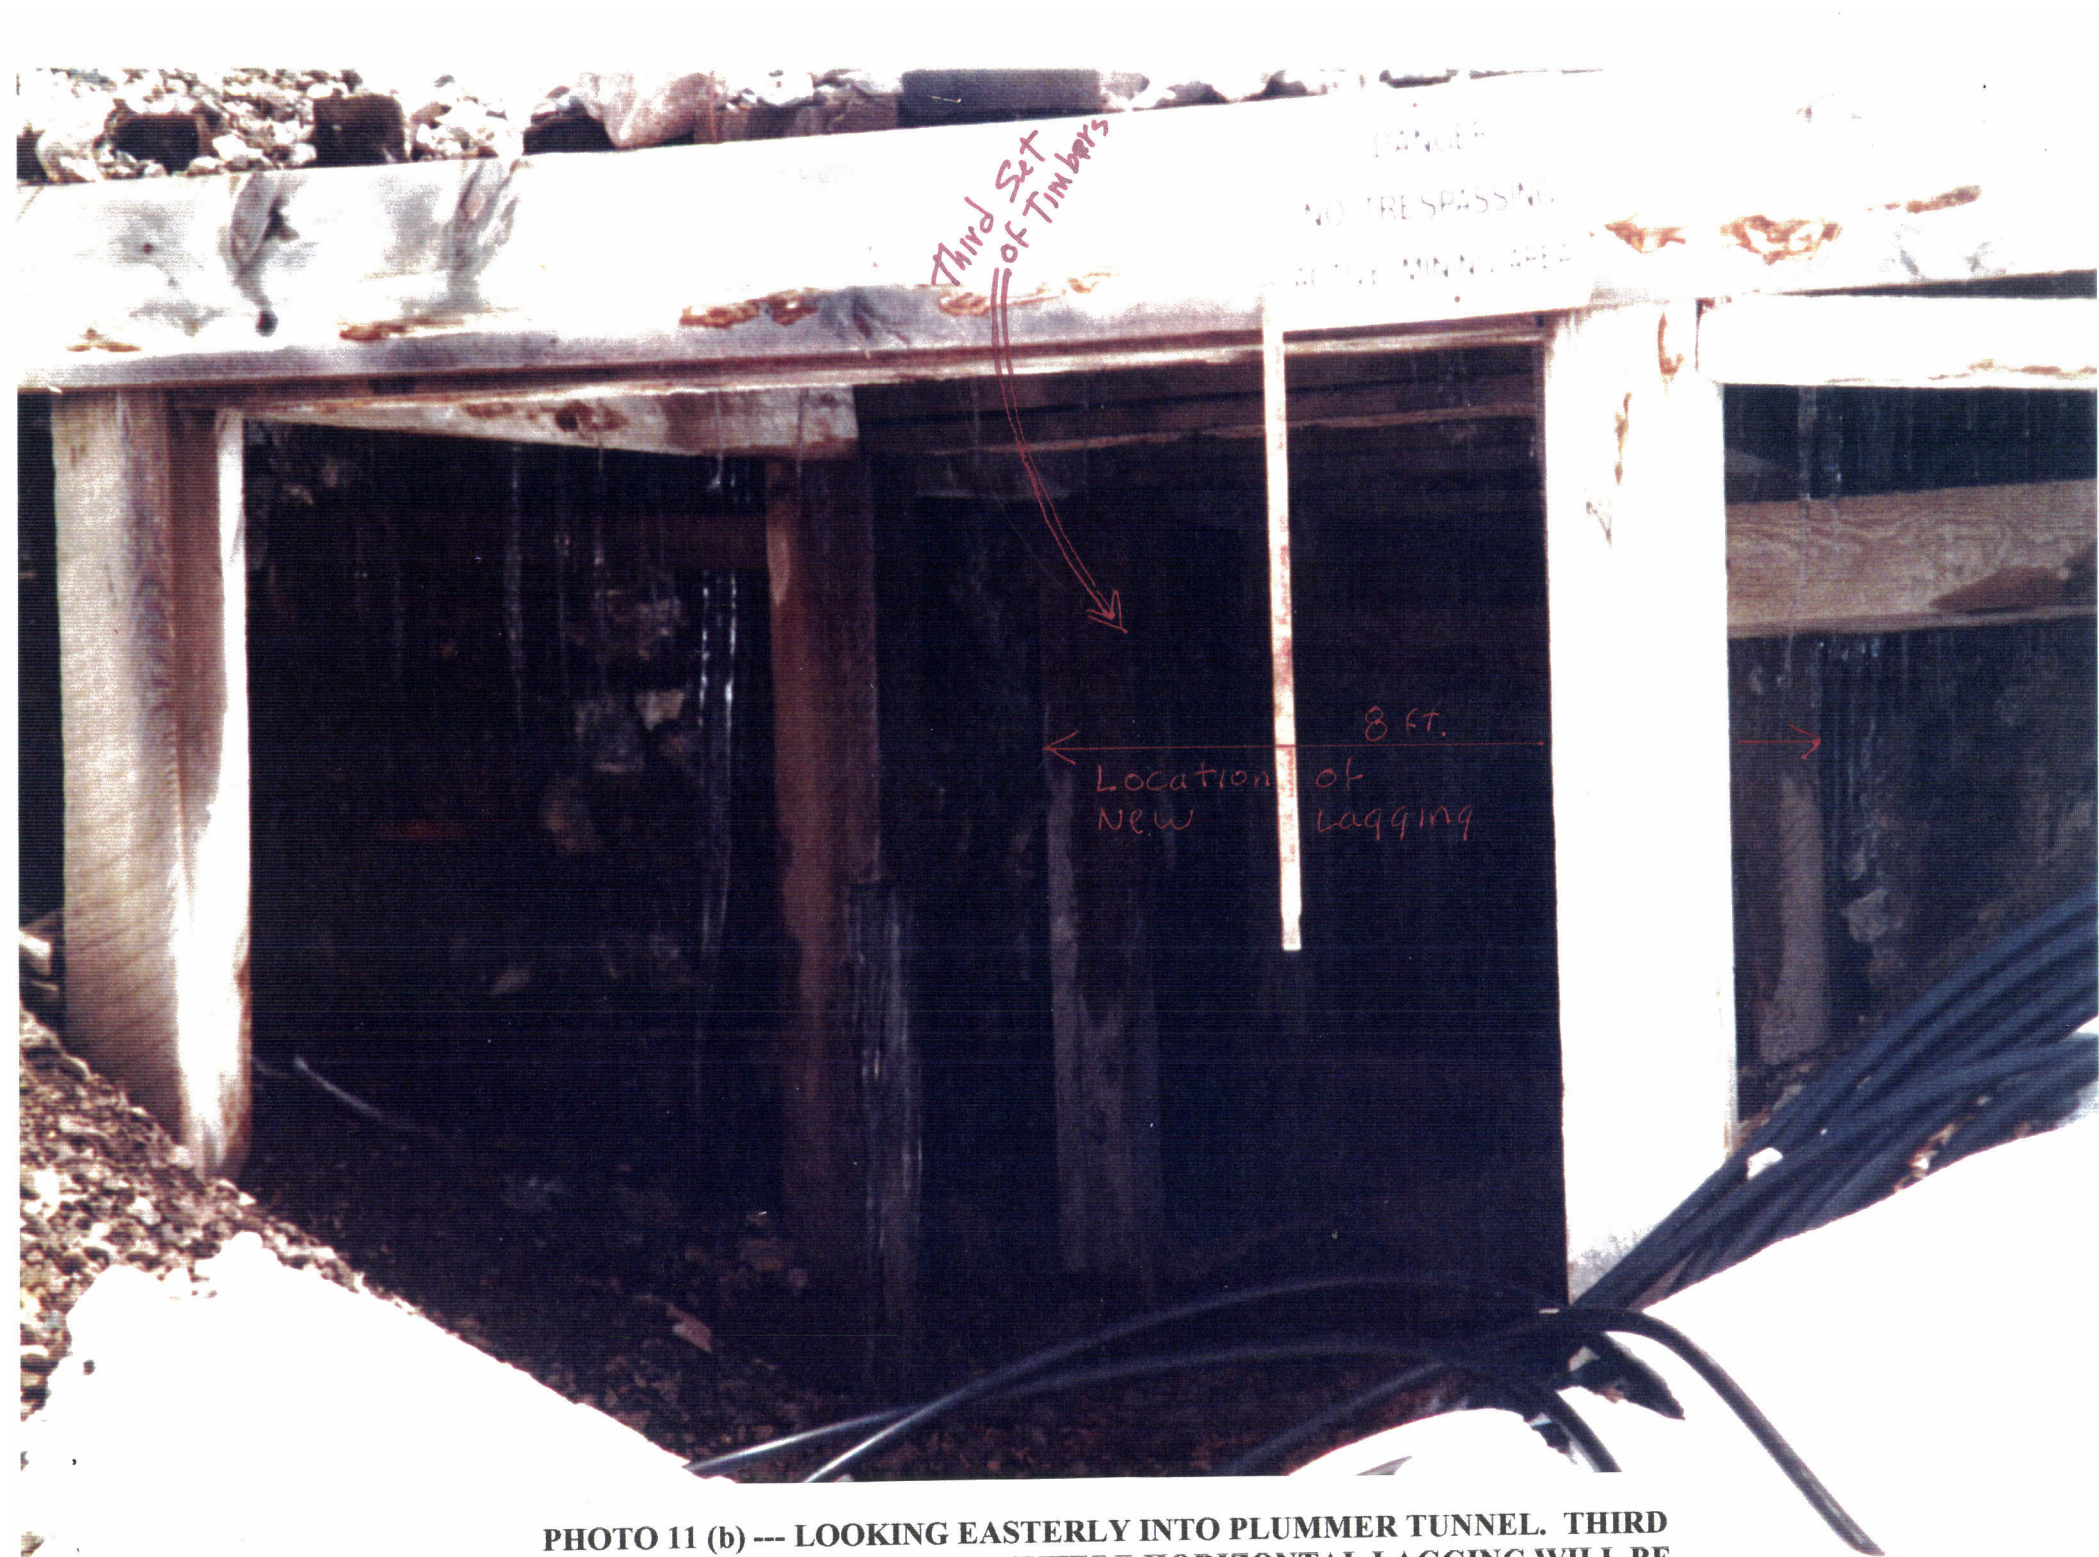
PHOTO 11 (b) --- LOOKING EASTERLY INTO PLUMMER TUNNEL. THIRD SET OF TIMBERS IS MARKED WHERE HORIZONTAL LAGGING WILL BE ATTACHED WITH 8 INCH LAG SCREWS.

Our planned closure of the Plummer Tunnel is to build a barrier using horizontal mine lagging at the third set of timbers (13 feet inside from the surface). See Photo 11-b. The portal opening is 14 ft. 9 in. with several 10 in. x 10 in. upright mine posts with caps rendering the portal safe (see photo 11-a). Thirteen feet inside from the portal, the tunnel itself begins. At this location, the tunnel width is 6 ft. (measured inside the first set of timbers) with a height of 6 ft. 3 in. It would be difficult, because of the irregular dimensions at the surface, to build an effective gate or barricade at the surface portal. Therefore, it is planned that 5 pieces of mine lagging (2 in. x 12 in x 8 ft.) be attached to the outside of the third set of timbers using 3/8 in. x 8 in. lag screws. This will leave no

more than 4 inches of space between the timbers (small enough to keep people out), and will render this tunnel secure from unauthorized access.

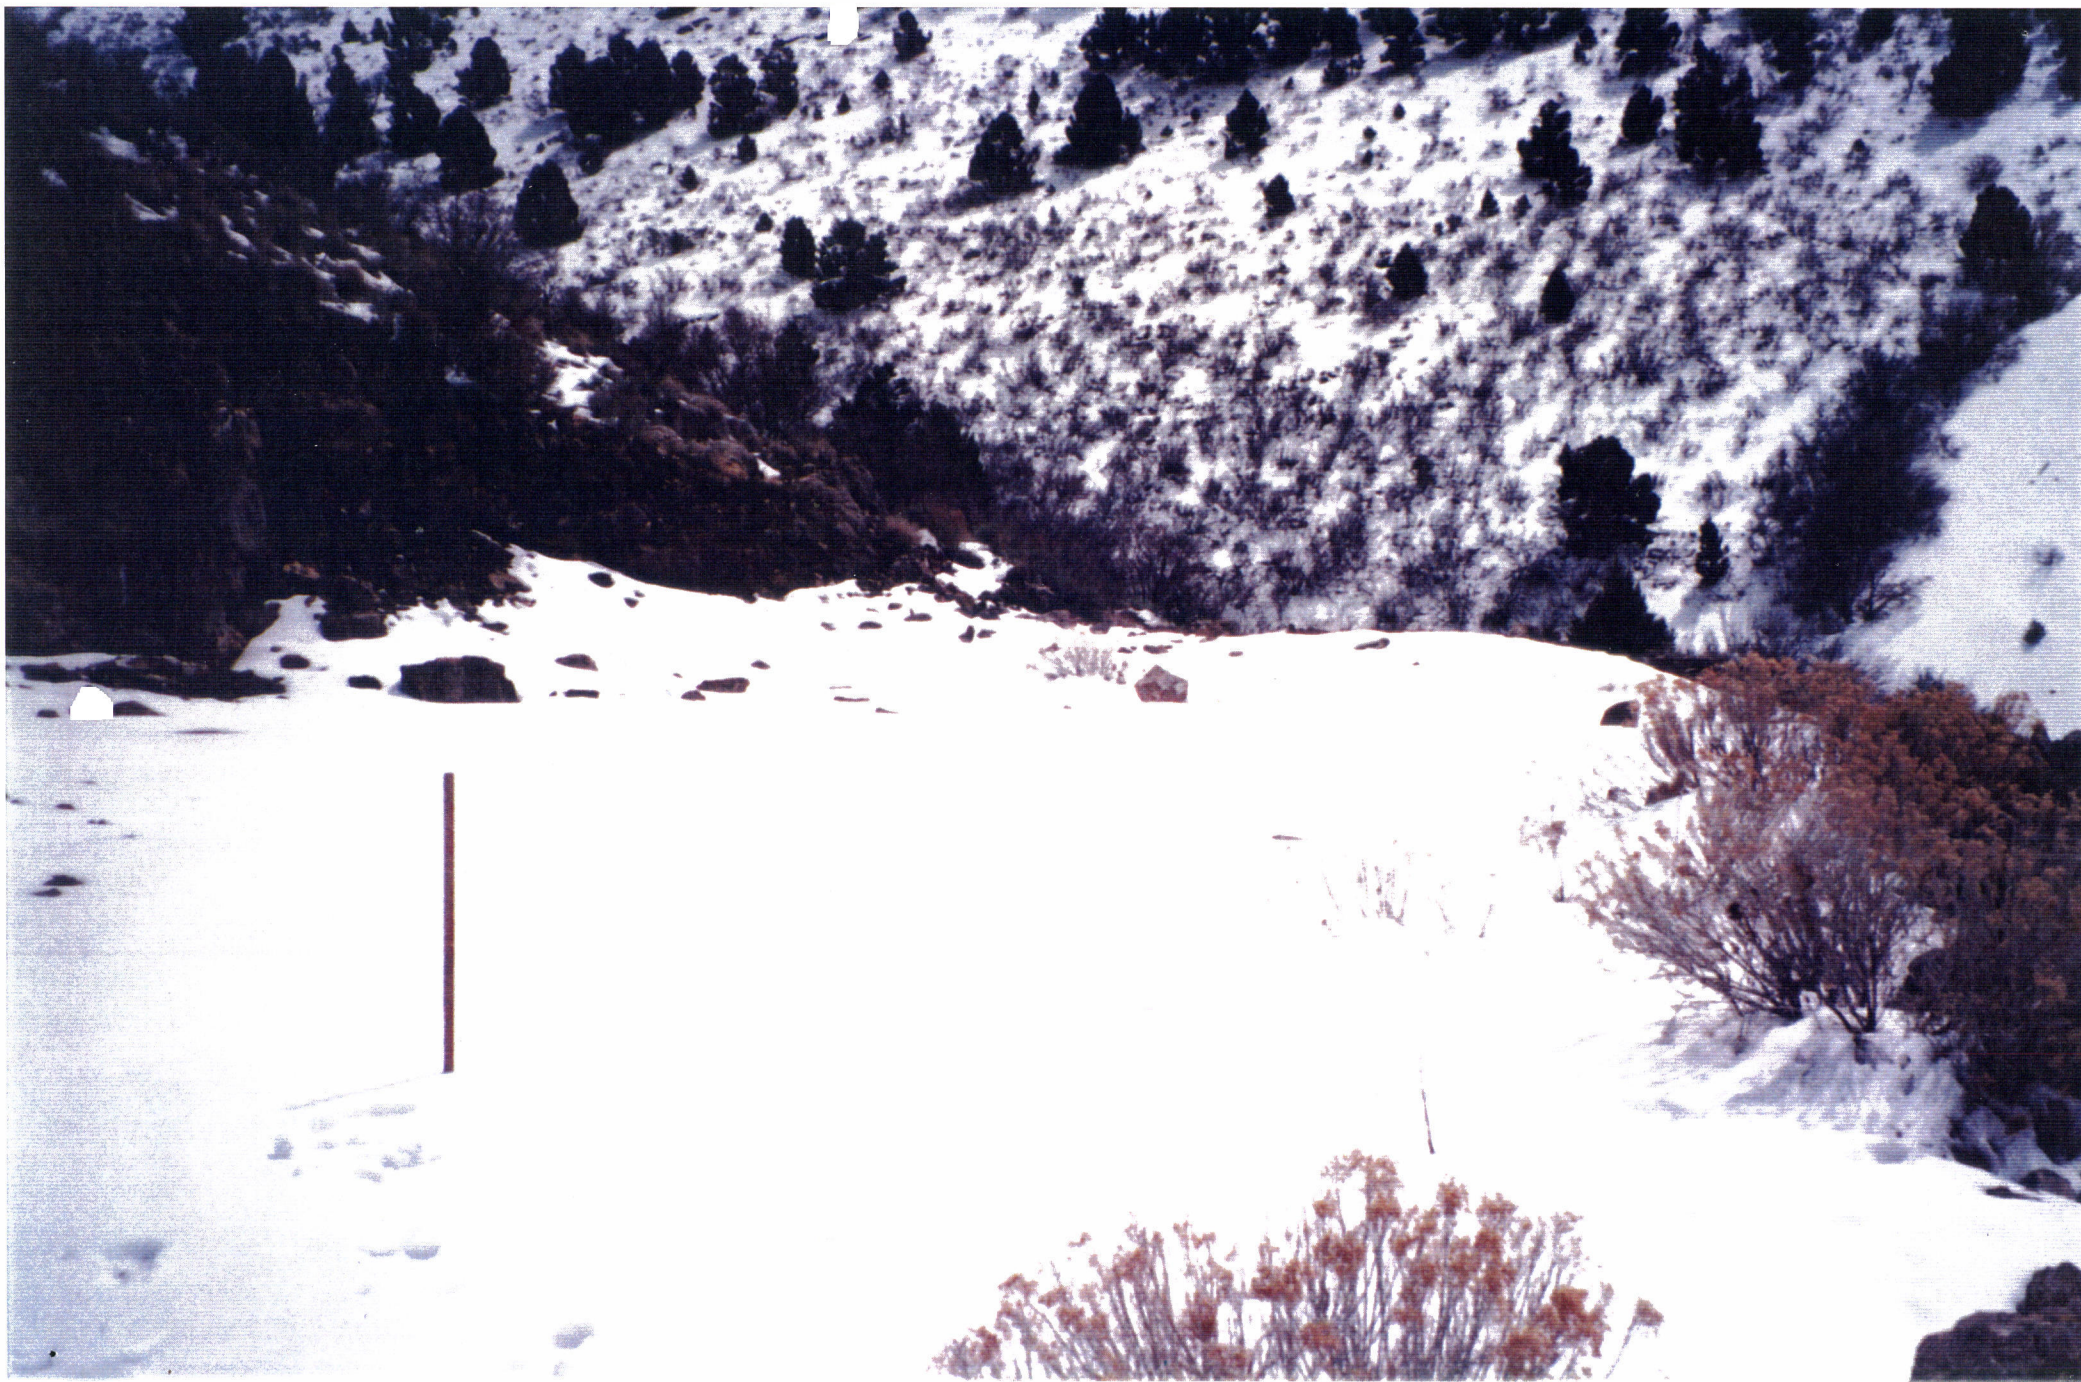
The drill pad has maximum length dimension of 76 feet (N-S) with a maximum width dimension of 52 feet (E-W)---see photo 13-a. This drill pad is currently being used as a "turn-around" on the Nad Breccia Road, and needs to be preserved for that use. We plan to use hand tools including rakes and shovels to smooth out the surface and plant native varieties of grass and other vegetation. The adits and prospect pits near the Ajax drill pad, including the Ajax mine adit, were constructed previous to July 1977. None of these pre-law adits or prospect pits were disturbed by mechanized equipment subsequent to July, 1977. The only post-law disturbance at or near this site, involves the repair of the previously existing Nad Breccia road and the construction of the Ajax drill pad near the end of that road.

**PHOTO 13 (a) --- LOOKING SOUTHERLY ALONG NAD BRECCIA ROAD
ACROSS AJAX DRILL PAD.**
